**First research report for the European Trade Union Confederation  
(ETUC)**

**Study on the safety of loft ladders and ladder feet**

As part of the implementation of ETUC STAND, the ETUC Standardisation project (Work Programme 2022)

**PROSIBAU Helmus Kelm Meins-Becker GbR**  
Contact: Prof. Dr.-Ing. Manfred Helmus

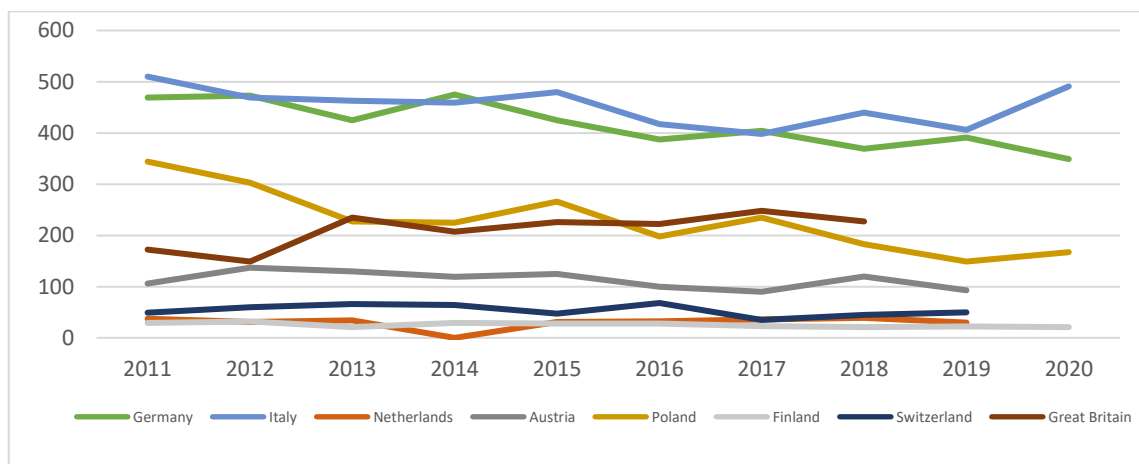
Figure 6: Development of the absolute number of deaths within the EU <sup>9</sup>

In addition to occupational accidents resulting in long periods of absence, fatalities can also occur. Again, based on the ESAW data, the economic sectors A\_C-N [Agriculture; industry and construction (except mining)] are considered. Figure 6 shows that Italy and Germany have by far the most fatalities. Over the period 2011-2020, the numbers range between 510 and 349, with the periodic fluctuation remaining fairly even. This is also evident in the other countries considered. Only Poland records continuously decreasing numbers. The absolute numbers must be considered in relation to the population density. The entire European Union remains constant in the development of work-related deaths and falls slightly. Compared to 2011 with a total of 3519 fatalities, in 2019 there are still 3008 work-related fatalities. The exit of the United Kingdom does not seem to have a significant influence on the development.

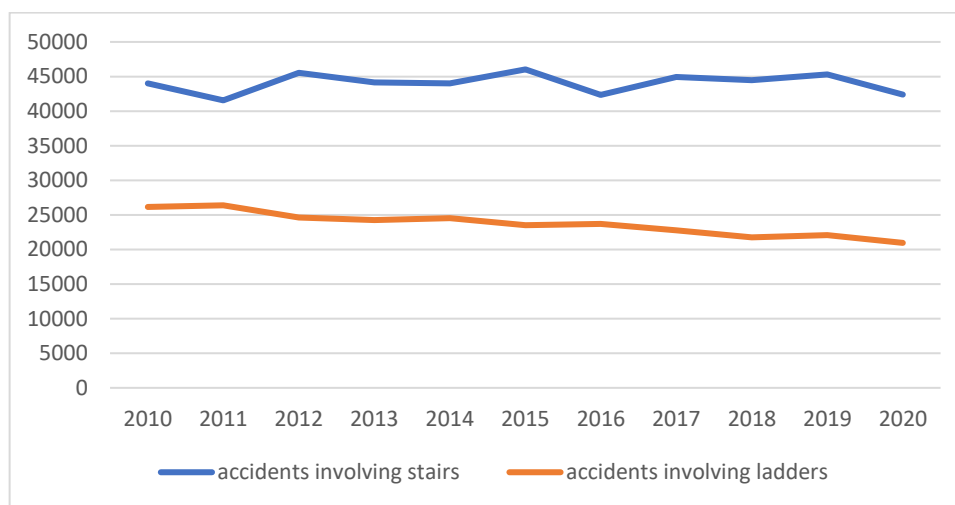
Figure 9: Development of ladder and stair accidents 2010-2020 in Germany, (all professions)<sup>19</sup>

The development of portable ladder and staircase accidents shows a slight downward trend in the case of ladder accidents. Here, accidents fall from 26,159 in 2010 to 20,953 in 2020. In the case of reportable accidents involving stairs, no precise trend can be observed. Here, the development stagnates on average at approx. 44,000 accidents per year.

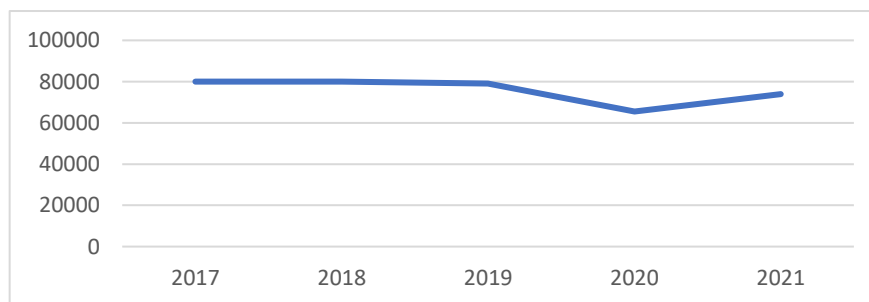
Figure 11: Development of occupational accidents in Great Britain <sup>21</sup>

The UK collects occupational accident data in the construction industry through the Health and Safety Executive (HSE). Accidents at work in the construction industry have a slight downward trend in recent years. In 2017, the incidence rate for fatalities in the UK was 1.37; in 2020, it is 1.62 per 100,000 inhabitants.

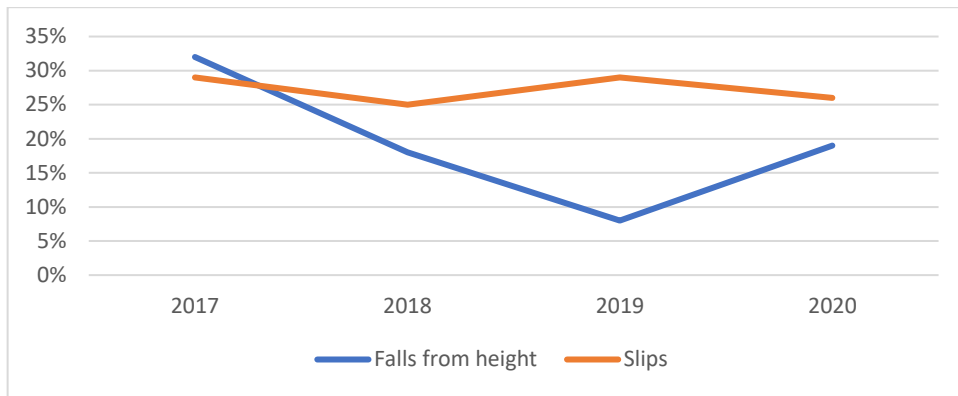
Figure 12: Percentages of the type for non-fatal occupational accidents in Great Britain <sup>22</sup>

Falling and slipping are the most common causes of non-fatal accidents. The development of these accident occurrences is still around 30% in 2017 and then diverges until 2019, only to converge again at 25% on average in 2020. The proportion of accidents caused by these two types of incidents has therefore not changed significantly and remains constant.

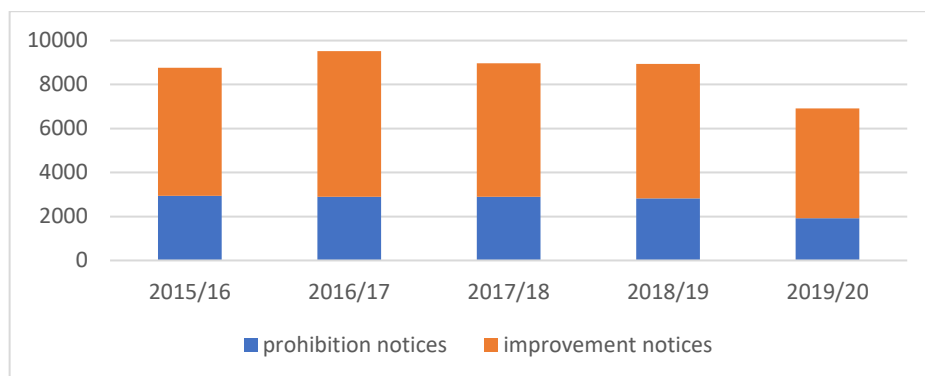
Figure 13: Development of prohibition and improvement notices<sup>23</sup>

In total, more than 6.3 million days have been lost due to occupational accidents (2020). This results in costs of £16.2 trillion that have to be borne by insurance companies. In addition to the pure accident statistics, the HSE also investigates the prohibition notices and improvement notices used within the construction industry. These are used as the first means of dealing with health and safety violations in order to improve the working environment or to immediately remedy dangerous situations.

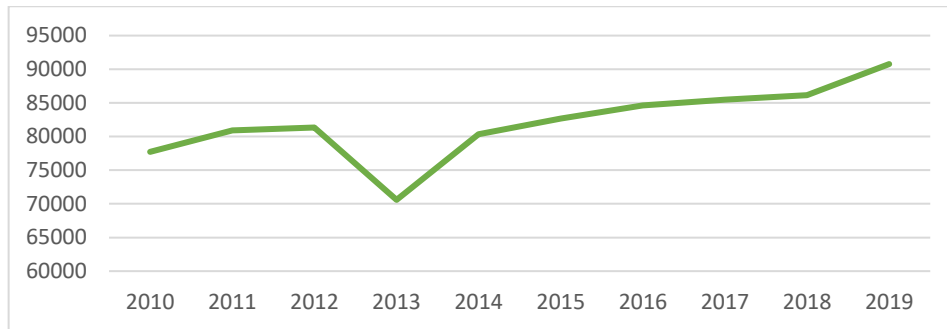
Figure 18: Development of occupational accidents due to slips and falls <sup>29</sup>

There are also clear age differences between the accident incidents. Slipping or sliding occurs more frequently with increasing age. Falling accidents also increase with age.

The most expensive accident categories are slips and accidents related to falls from height. On average for the years 2015-2019, the accident insurance institutions in Switzerland attributed 41% of the costs, i.e. the insurance benefits incurred, to occupational accidents caused by slipping and sliding. The same applies to falls. These caused a total of 22% of all costs in the assessment period.<sup>30</sup>

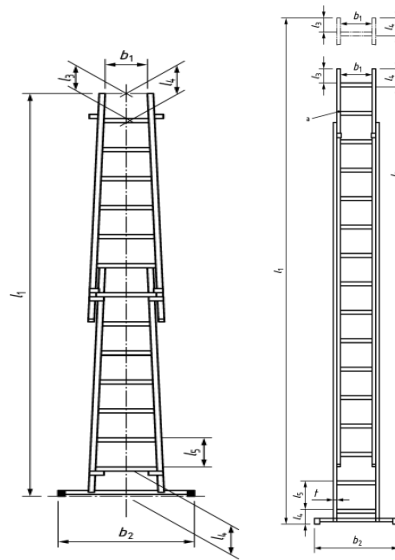
Figure 19: Types of extension ladders<sup>38</sup>

For the definition of the design features and test methods applied, EN 131-1:2015+A1:2019, as well as EN 131-2:2010+A2:2017 and EN 131-3:2018 are decisive in the case of the ladder types examined, particularly, the ladder types 3.7 and 3.8.<sup>35</sup> According to the standard, the stabilising traverse is a "device attached to the lower end of the ladder for increasing the stand width.  $b_2$  and to increase the stability ".<sup>36</sup>The current minimum stand width for rung ladders, which also include extension ladders, can be found in Table 2 in combination with Figure 19:

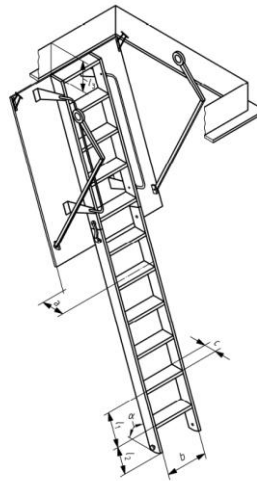
Figure 20: Illustration of a sliding/folding loft ladder<sup>44</sup>

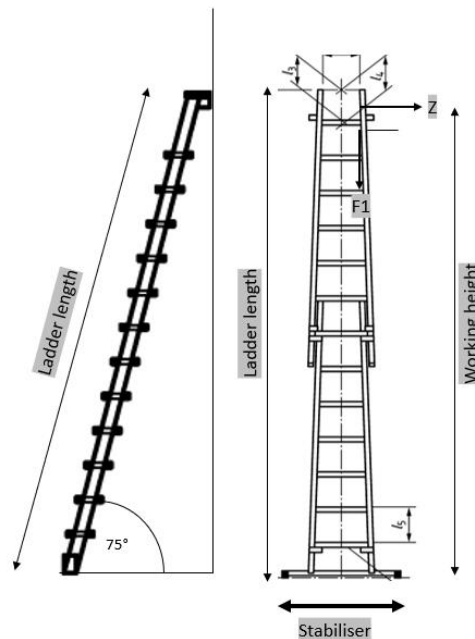
The ladder should not show any visible defects such as cracks or deformations during and after the test and should remain functional. Otherwise, the test would have been aborted and carried out under adapted boundary conditions.

Figure 23: Schematic representation of the experimental set-up

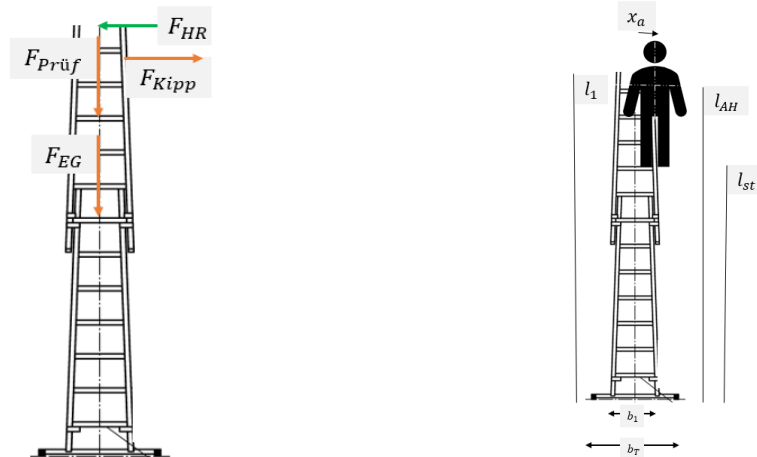
$$\begin{aligned} (\text{tipping force [N]} = \text{testload [N]} * [(\text{crosshead [cm]} * 0,5) - \text{eccentricity [cm]}] + \\ (\text{deadweight [kg]} * 9,81 * 0,5 * \text{crosshead [cm]})) / (\text{working height [cm]}) \end{aligned} \quad (3)$$

Figure 24: Forces and variables involving the calculations

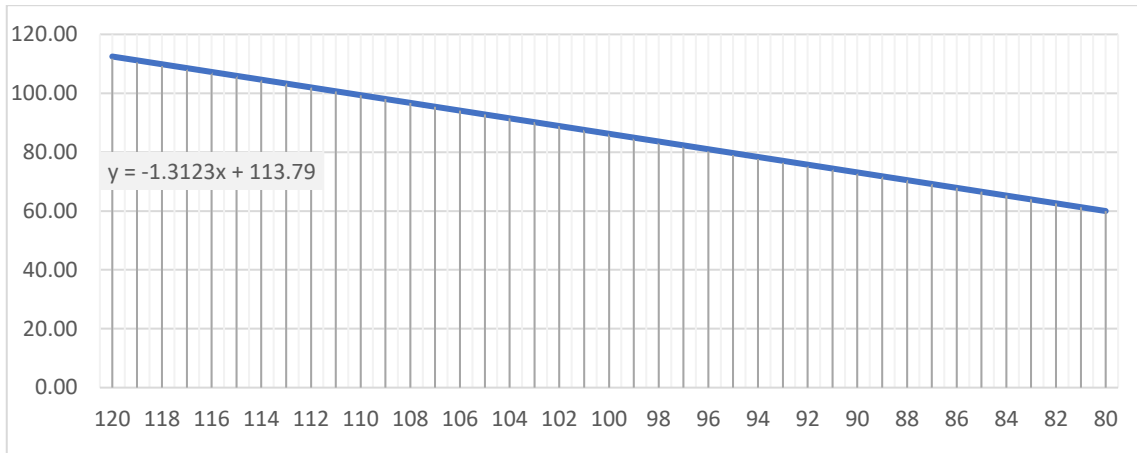
The results show that the applied test force had a positive effect on stability and that its position on the ladder is the decisive criterion. Using the variables from Table 6, which result from the regulations and the manufacturer's specifications in Table 6, a tipping force of 112.47 N (11.47 kg) was obtained for a truss length of 120 cm. Figure 25 shows that the stability of the ladder decreases linearly with the reduction of the truss length. The calculation of the tilting force K, under the given boundary conditions, can therefore be done with the formula:  $y_{[120-80]} = -1,3123x + 113,79$ , with x equal to the stabiliser length.  $F_{Kipp}$  is 73.11 N (7.45 kg) for a truss length of 90 cm. This corresponds to a loss of stability of 35 % with a reduction of the truss width by 30 cm.

Figure 25: Graphical representation of the correlation of the tilting force [N] to the stabiliser length

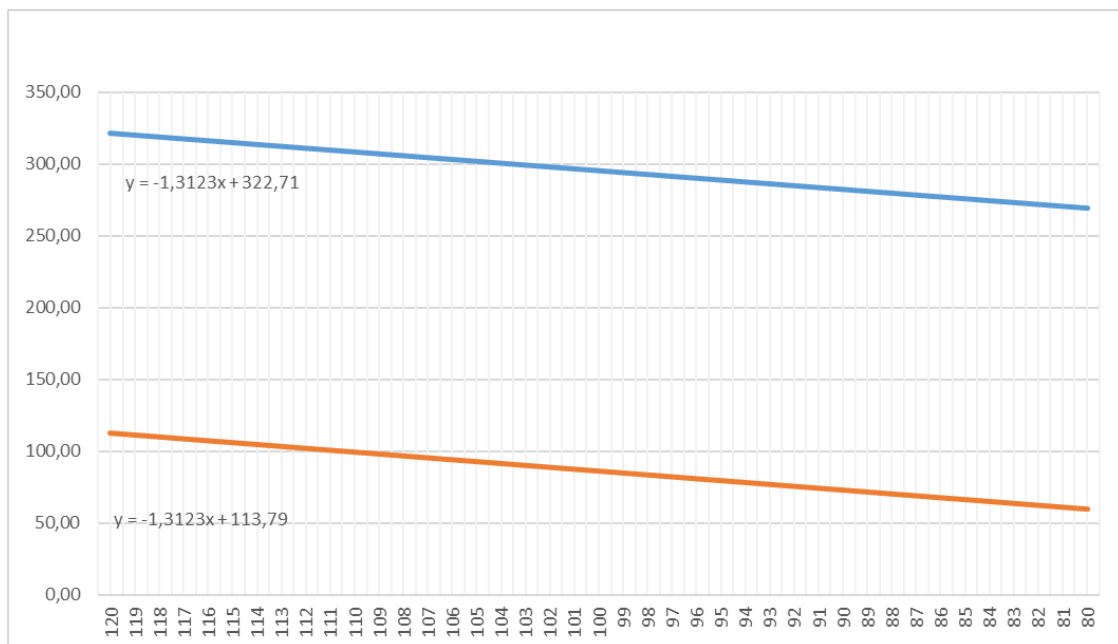
The comparison of the different tipping forces and the associated loss of stability shows that the frictional forces have a significant share in the stability of the ladder.

Figure 26: Comparison of the calculated overturning forces with and without consideration of static friction forces, orange: without static friction, blue: with static friction

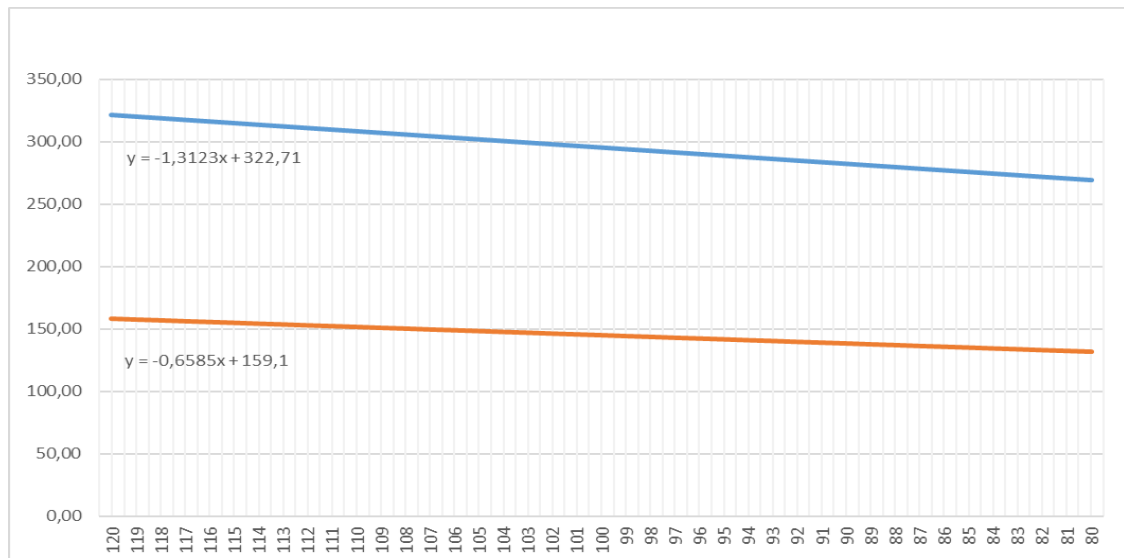
Figure 27: shows the comparison of the new parameters with the previous calculation. Although the loss of stability of the system is approximately the same at 12.47%, the force  $F_{Kipp}$  with a crossbar length of 120 cm lies at 158.44 N (16.15 kg). With a reduction to 90 cm, this is only 138.68 N (14.07 kg). The significance of the user's own weight can thus also be noted as decisive for a stability consideration.

Figure 27: Comparison of the changed parameters, orange: 1500N, blue: 650N

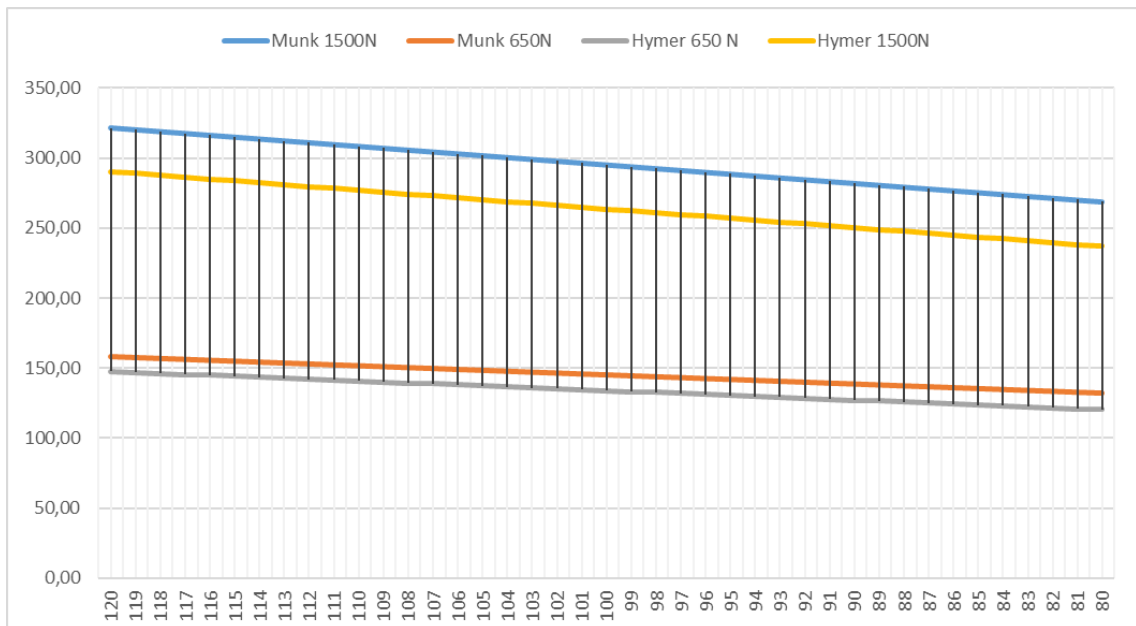
the calculated scenarios shows that in the worst case a person with a low body weight and a steep angle of attack uses the ladder. If, in addition, the contact surfaces of the ladder are wet, e.g. due to rain or wiping water, the frictional force can quickly decrease, resulting in a severe loss of stability.

Figure 28: Overall comparison of the test objects [N]

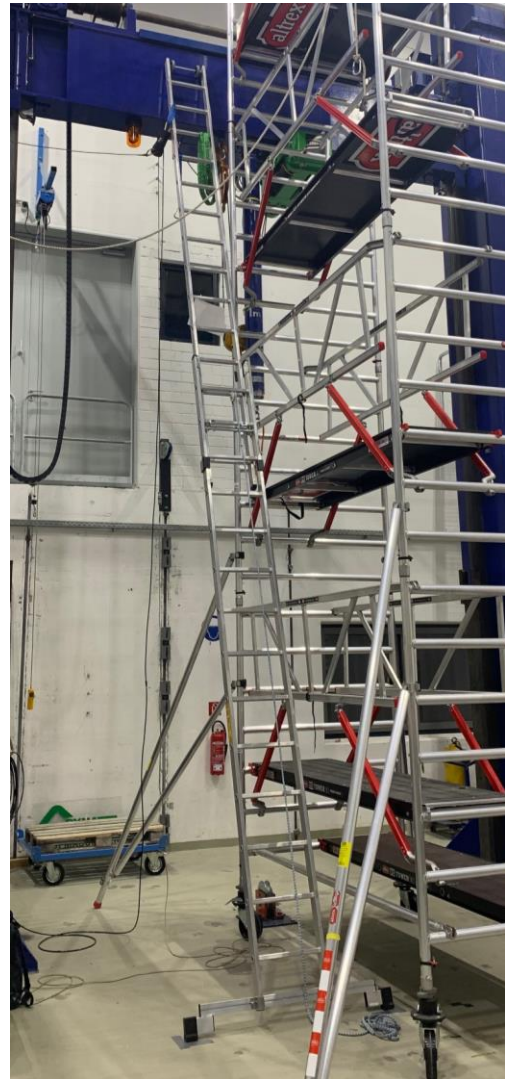
In the test hall of the Arbeitsschutzzentrum Haan, the Munk ladder was leaned against a stabiliser at an angle of  $75^\circ$ . The ladder was only extended to a standing height of 5 m and a corresponding working height of 6.5 m. The ladder was then used for the test. A scaffold was placed next to the ladder, which allows the various test weights to be changed on the ladder during the test without stepping on it. At the level of the second rung from the top, the test cell was placed to measure the overturning force. The test cell was loaded horizontally from the side via a pulley. The test weight was attached to the outside left of the rung with a loop. The test weights were brought into position with a gantry crane and slowly hooked in so that the load does not start abruptly. The stabiliser was marked every 5 cm, for easy adjustment. After the test, the weight was lifted from the crane again, the stabiliser was loosened and shifted by 5 cm, as in Figure 31, so it became shorter on one side. The tests were repeated per test weight until all stabiliser lengths had been tested. Then the test weight was changed. At the end of the tests, the tipping force was determined for both test weights in case they were placed in the middle of the ladder rung.

Figure 29: Experimental set-up

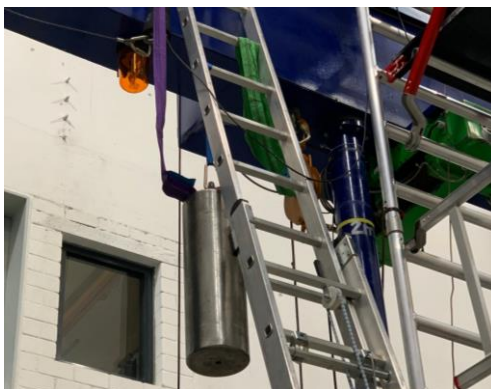
Figure 30: Test weight on the ladder

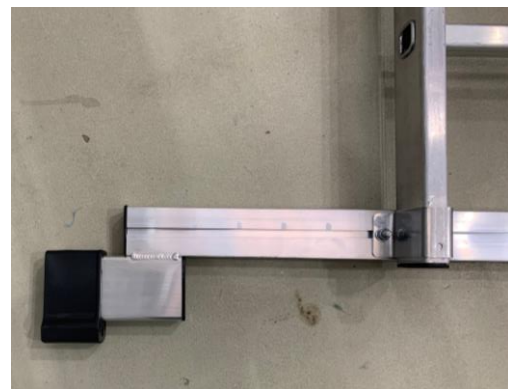
Figure 31: Marked stabiliser

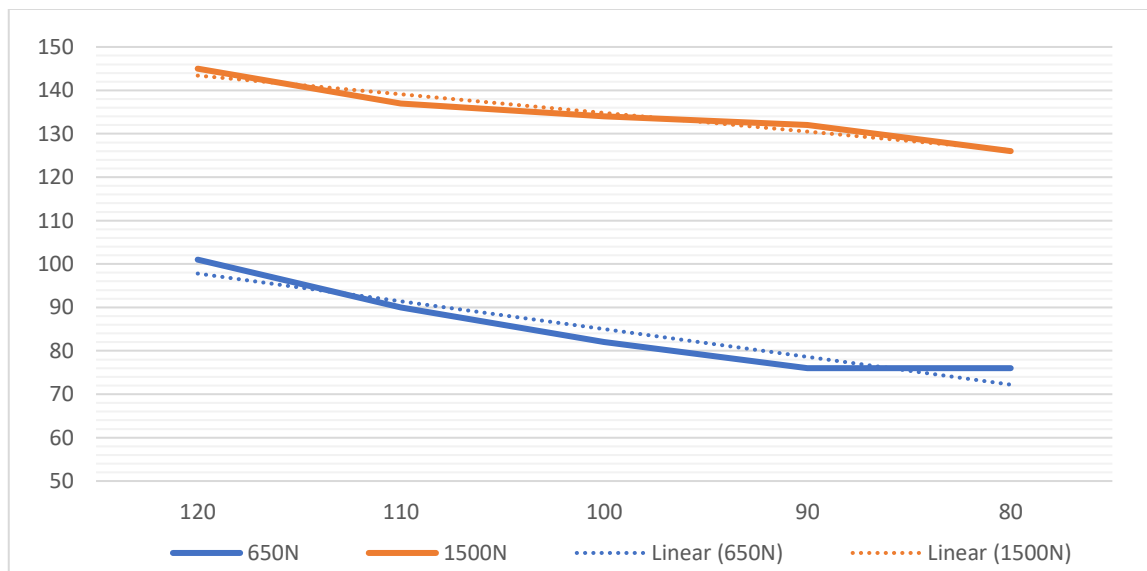
If one compares both results graphically, an almost linear course of the tipping force in relation to the stabiliser length can be seen. The test force or the weight of the user also has a considerable influence on the basic level of the tipping force. The different inclines indicate that the frictional force also has a variable influence on the tipping force depending on the test weight.

Figure 32: Graphical representation of the tilting force as a function of the stabiliser length

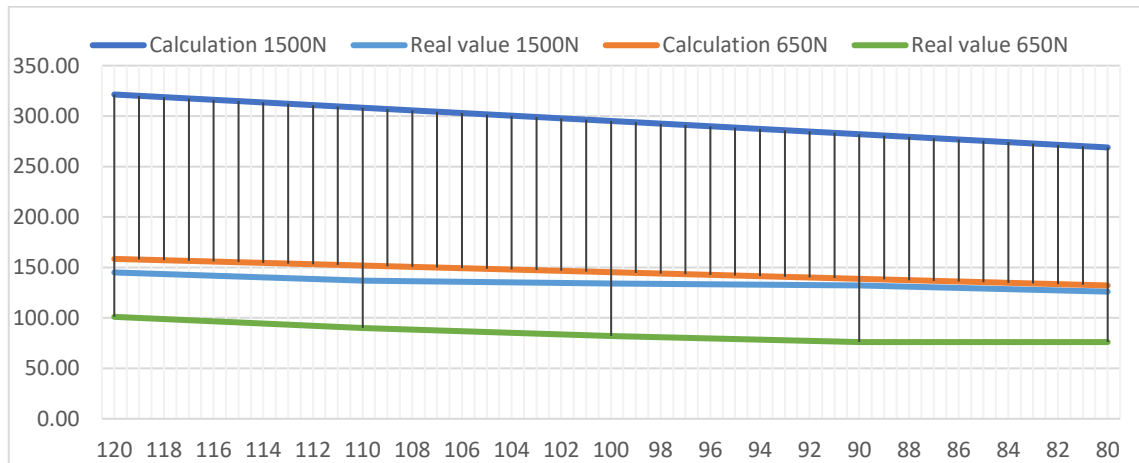
The following graph shows the direct comparison of the calculated tipping forces and the forces determined in the test set-up. It can be seen that the deviations of the correlating calculations with the real tests are particularly noticeable with the higher test weight. This is mainly due to the real boundary conditions and test inaccuracies, as well as incorrect assumptions. The real tests showed that the ladder started to slip at the upper contact surface, which indicates a much lower static friction than assumed originally.

Figure 33: Comparison of calculations and carried out testing [N]

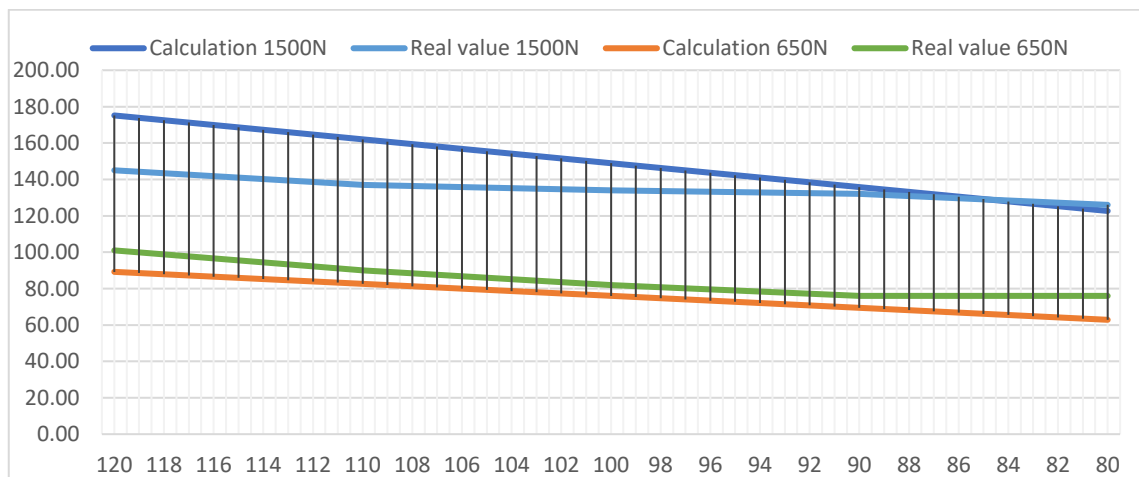
If the static friction force is adjusted to 0.12 [-], the graphs match more and overlap partly. The slope is also approximate, although in the case of the larger test load, clear differences can still be seen. The testing weight seems to have a more stabilising influence than calculated.

Figure 34: Comparison of adjusted calculations and carried out testing [N]

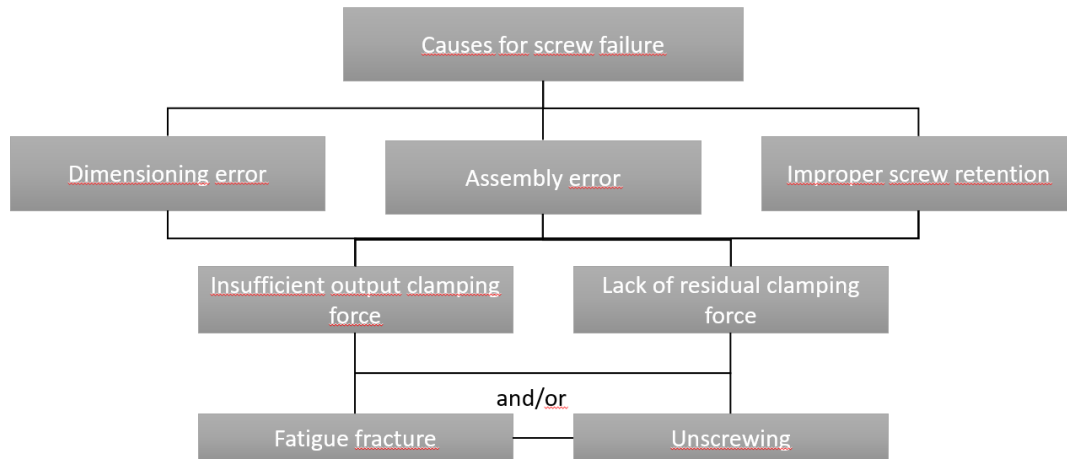
For the test, the bolted connections are probably of particular relevance. Vibration stress in particular often leads to loosening of bolted connections due to creep/settling or automatic loosening. The failure of the connection can be caused by three reasons: Dimensioning errors, assembly errors and improper use of thread lockers (Figure 35).<sup>53</sup>

Figure 35: Causes of unfastening and failure of bolted joints <sup>54</sup>

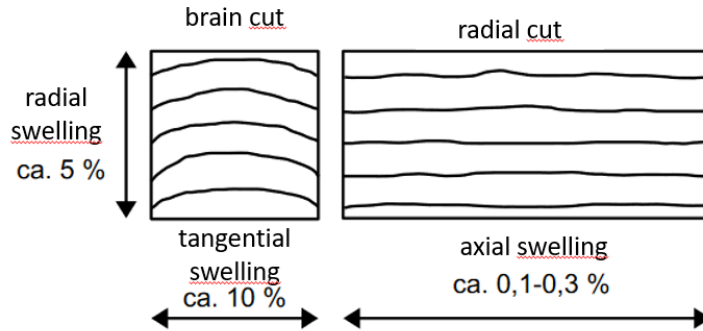
increase or decrease in moisture has no further effect on shrinkage and swelling. In general, swelling occurs until the fibre saturation point is reached. Shrinkage only starts again when the value falls below the saturation point.<sup>58</sup> Since wood is an anisotropic material, the volume change in axial, tangential and radial direction to the wood fibre occurs in different magnitudes (Figure 36).

Figure 36: Maximum change in length due to contraction and shrinkage<sup>59</sup>

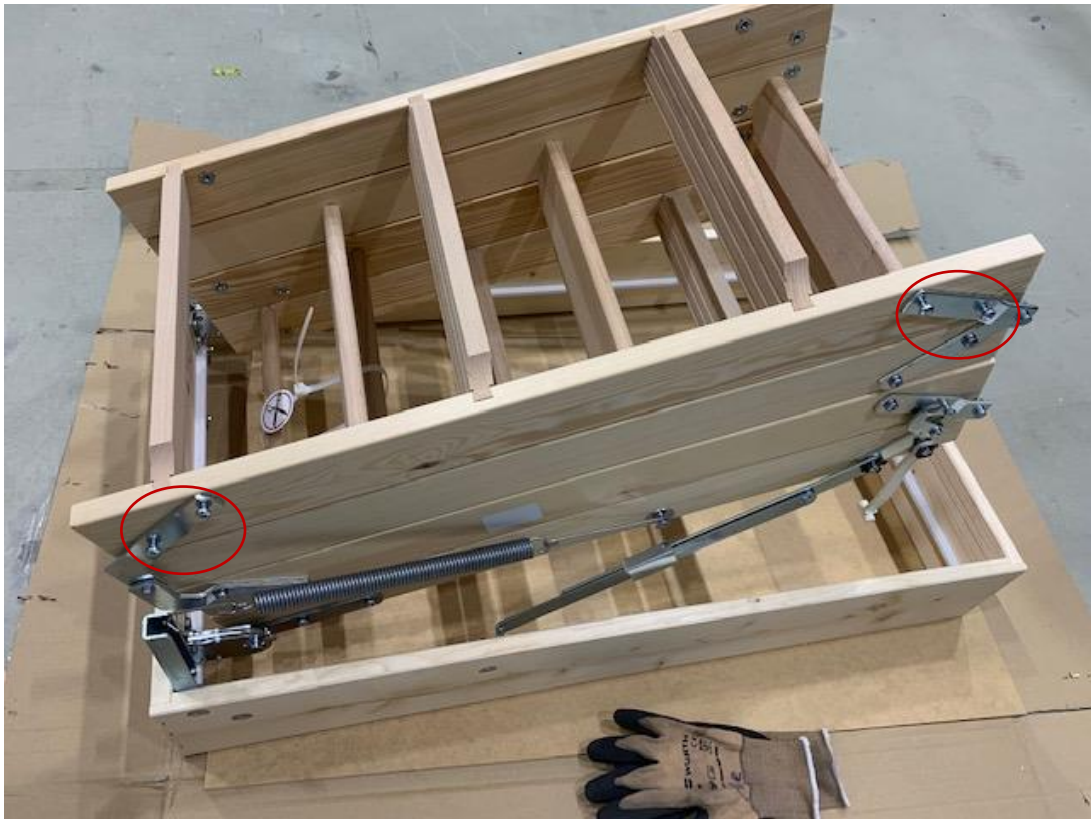
After delivery of the loft ladder system, the ladder was first pre-assembled according to the operating instructions. All screw connections that have to be mounted by the user were initially only screwed in halfway to make it easier to distinguish them. A total of 44 screws were pre-assembled by the manufacturer. 14 screws had to be tightened by the user during assembly, 6 of which were pre-assembled and were used to fix the cover. 8 screws had to be newly mounted to connect the lower ladder section (Figure 40).

Figure 38: Loft ladder system preassembled, screws to be installed are marked

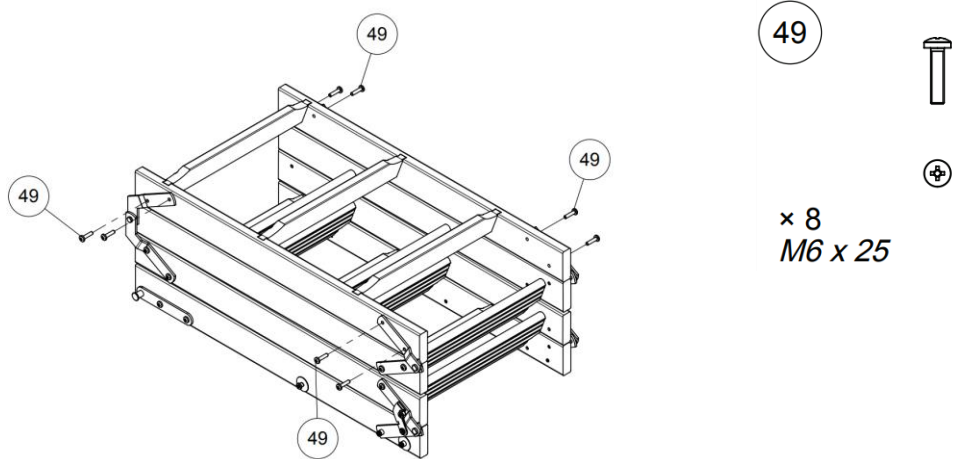
Figure 40: Section of the assembly instructions, position 49

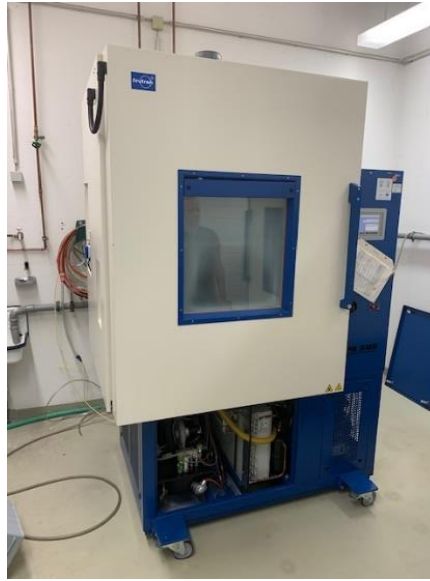
Figure 41: Climate chamber of the Haan Occupational Safety and Health Centre

After completion of the preparations, the entire loft ladder was placed in the climate chamber (Figure 44) in the collapsed position.

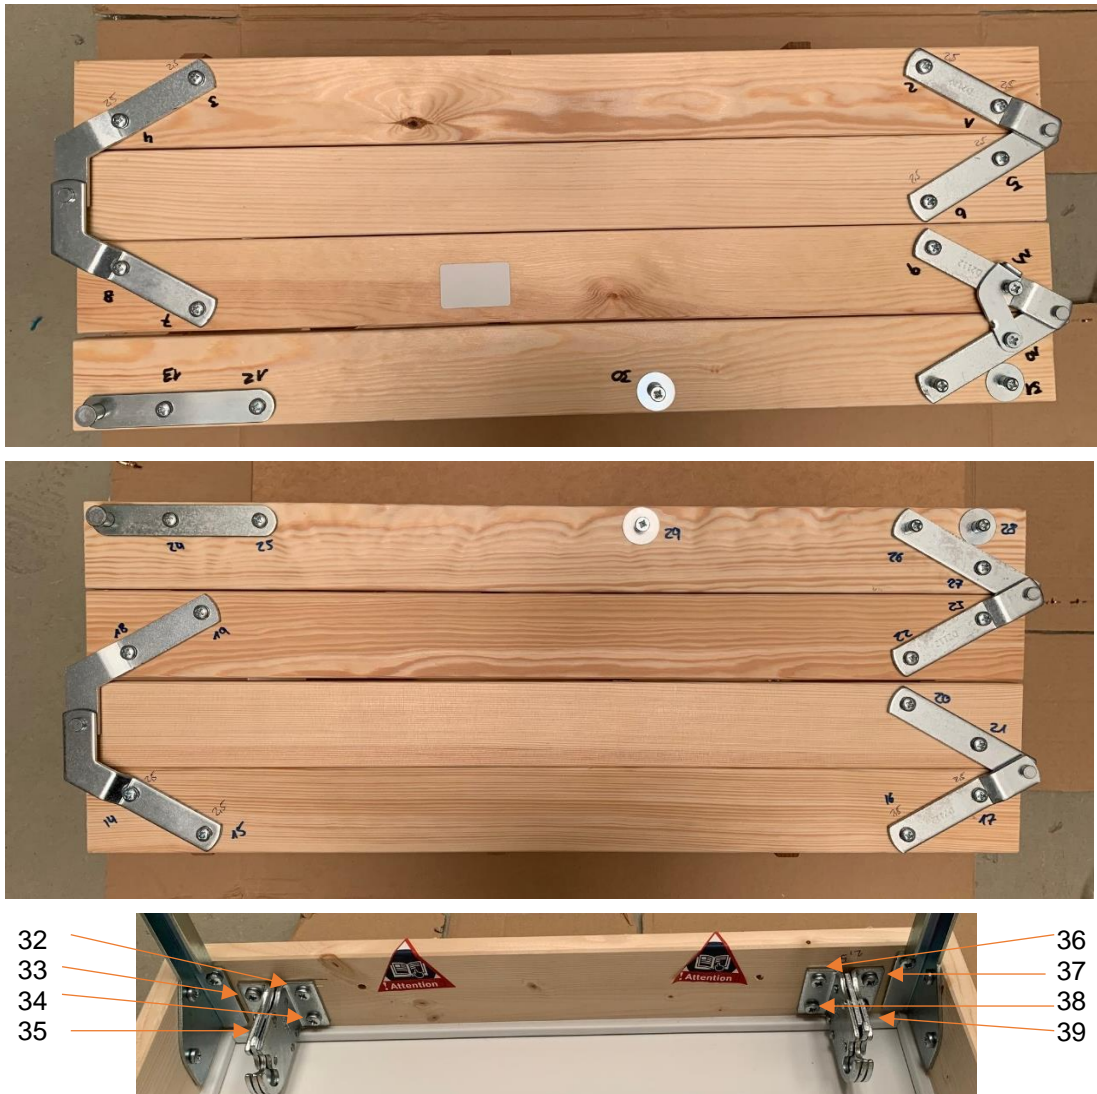
Compared to the reference values before the test cycles, the expected release torques increased in the majority of cases. 5 of the bolted joints had a release torque below 1 Nm. On average, the bolts had a release torque of 1.46 Nm. At peak, a value of 2.9 was achieved.

Figure 42: Overview of the tested screwed joints
